ILLICIT DISCHARGE DETECTION & ELIMINATION PROGRAM

AT THE US NAVAL ACADEMY/
NAVAL SUPPORT ACTIVITY
ANNAPOLIS

Matthew Klimoski, P.E.

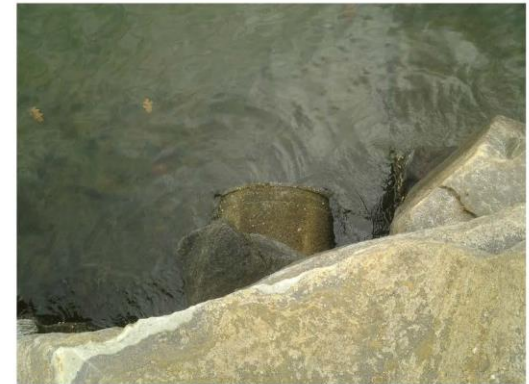
Outfall Photo

Facing South

Outfall Assessment	
Outfall Type	Pipe
Outfall Material	Reinforced Concrete Pipe
Outfall Diameter (in)	24
Outfall Structural Condition	Normal
Type and Condition of Vegetation:	N/A
Signs of Erosion?	No

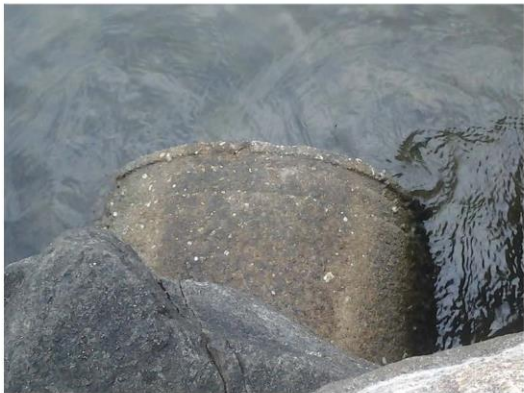
Outfall Assessment Photo

Dry Weather Flow Observed?	No Dry Weather Observed
Structure 1	
Structure 1 Type	Inlet
Asset ID of Structure 1	AP41-SD-6816
Structure 1 Material	Reinforced Concrete
Condition of Structure 1	Normal
Structure 1 Surcharged?	Yes

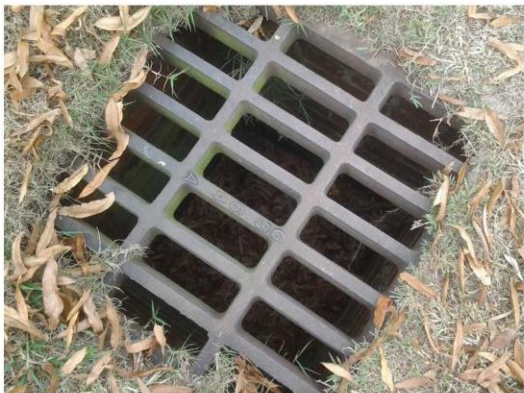
Structure 2 Photo

No Dry Weather Observed

Structure 2	
Structure 2 Type	Inlet
Asset ID of Structure 2	AP41-SD-8778
Structure 2 Material	Brick
Condition of Structure 2	Normal
Structure 2 Surcharged?	No
